# Weekly Construction Report

## Hatchery Creek Design/Build Project

<b>Week:</b>	October 6-11, 2014	<b>Project No:</b>	1305
<b>Rain Days/Weather Conditions:</b>	Rained 0.6" Monday-Tuesday, 0.8' on Thursday, & .0.7" on Friday for a total of 2.1" this week (Burkesville gauge).		
<b>Personnel on-site:</b>	<i>EcoGro/Ridgewater:</i> John Arthur, Tony Berry, Tom Cutter, Eric Dawalt, Jim Hanssen, Jon Linder, Chad Relinski, Brad Redmon, & Russ Turpin. <i>Stantec:</i> N/A		
<b>Equipment on-site:</b>	Komatsu PC 160 w/ hyd. thumb, PC 360 w/ hyd. thumb, Terex TA27, Bobcat T300		
<b>Material deliveries to project site:</b>	<ul style="list-style-type: none"> <li>N/A</li> </ul>		
<b>Work performed this week:</b>	<ul style="list-style-type: none"> <li>Repaired mass slope failure of existing ravine soil bank on right side of temporary diversion channel. It was apparently caused by saturation of the soil due to water seepage from the channel along a buried "<b>solution feature</b>". The solution feature is roughly horizontal and appears to consist of a 2- to 6-inch layer of manganese, iron, and/or other minerals, possibly at a former water table level.</li> <li>Installed temporary clay dam (covere

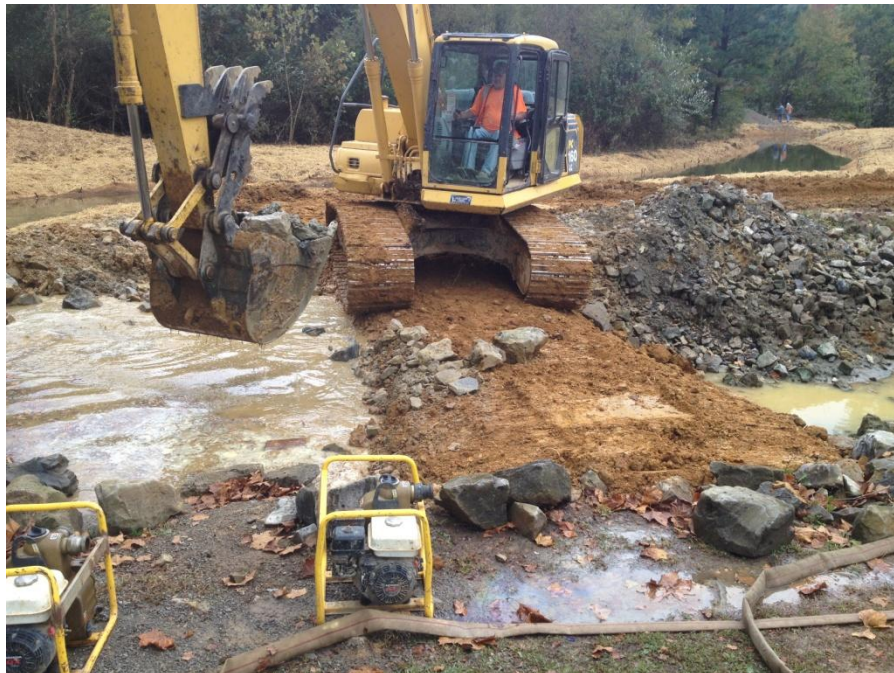
***Installing temporary clay dam in existing "rip rap channel" in Public Fishing Area (~Sta.104+00) to divert all flow into temporary diversion channel. It was subsequently covered in rock.***

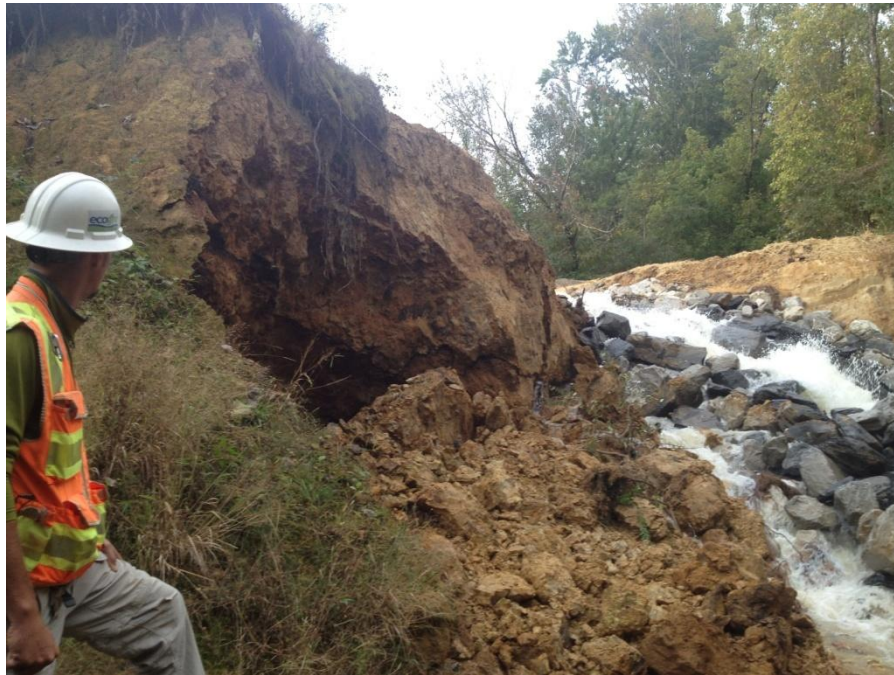
***Mass slope failure of existing ravine soil slope on right side of temporary diversion rock chute channel (~200 LT of Sta.106+00).***

Irregular, dark brown layer is "solution feature"

Flow along "solution feature"

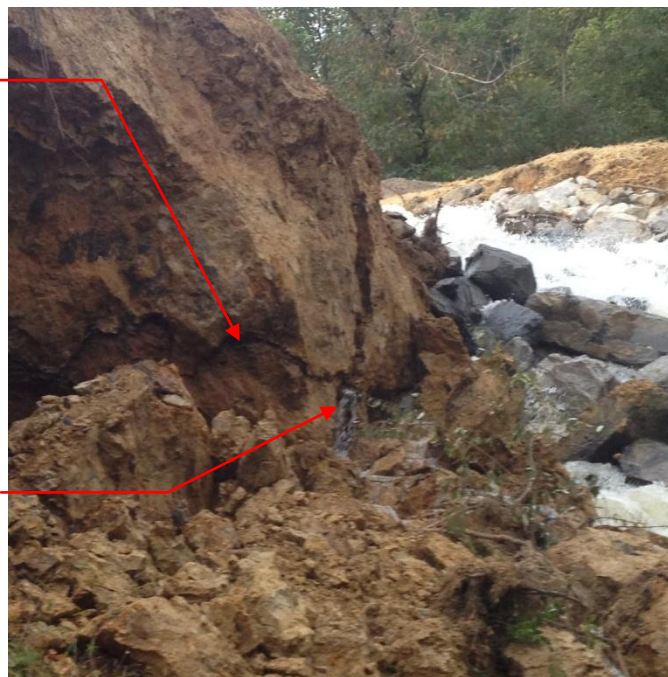
***Close up of same photo showing "solution feature" in soil with water pouring out of it.***

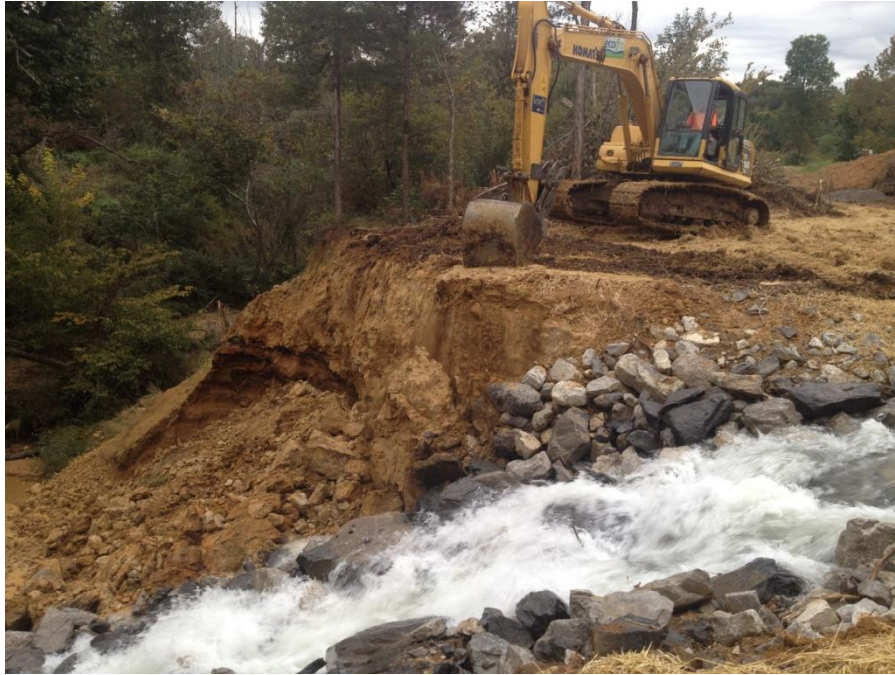
***Repairing mass slope failure of ravine soil bank adjacent to temporary diversion channel. (~200 LT of Sta.105+50).***

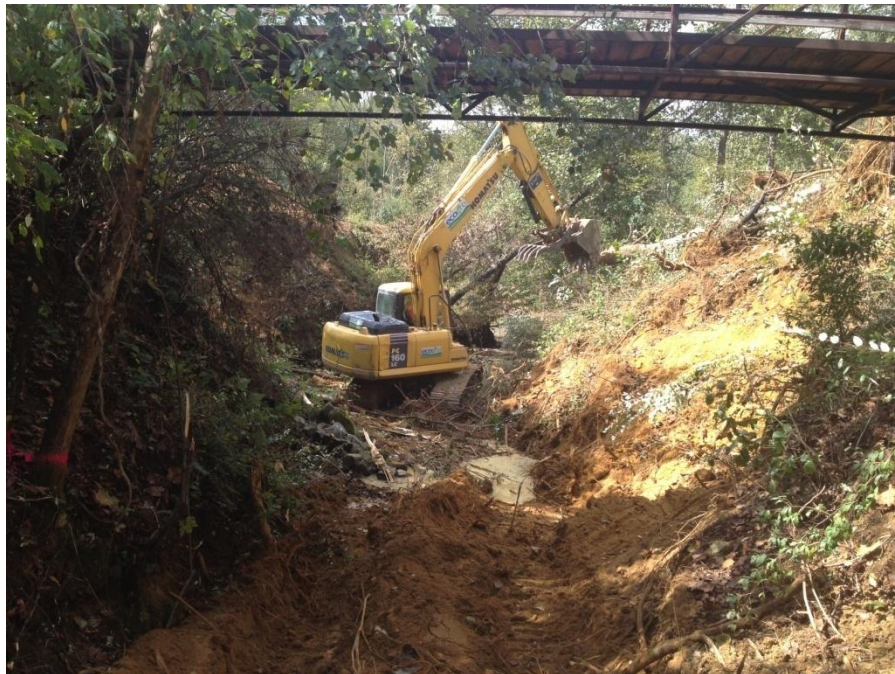
***Clearing trees in ravine downstream of bridge (looking downstream/LT from RT Sta.106+30).***

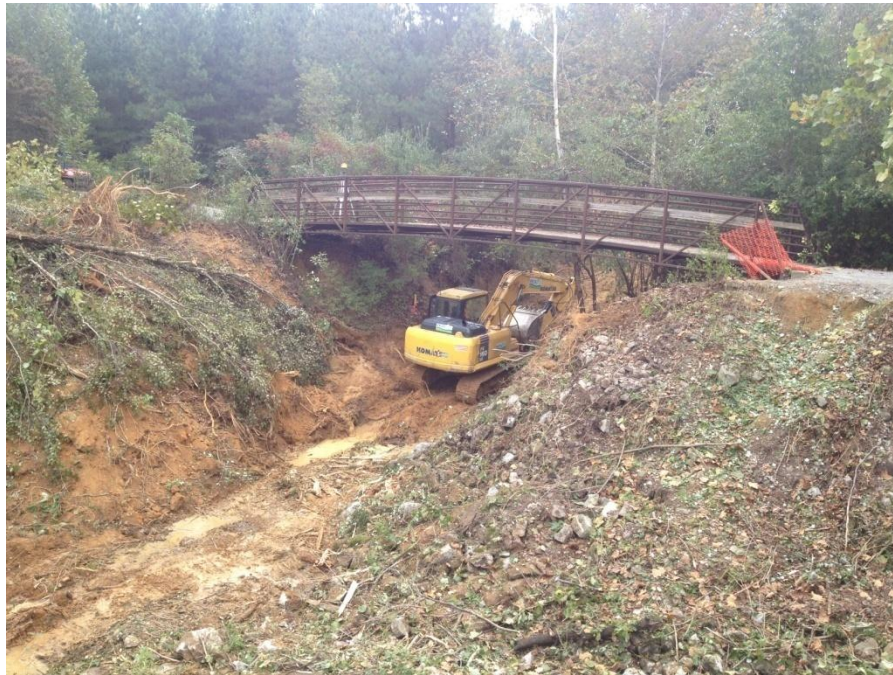
***Ravine after clearing. (Looking upstream/RT at ~Sta.106+00).***

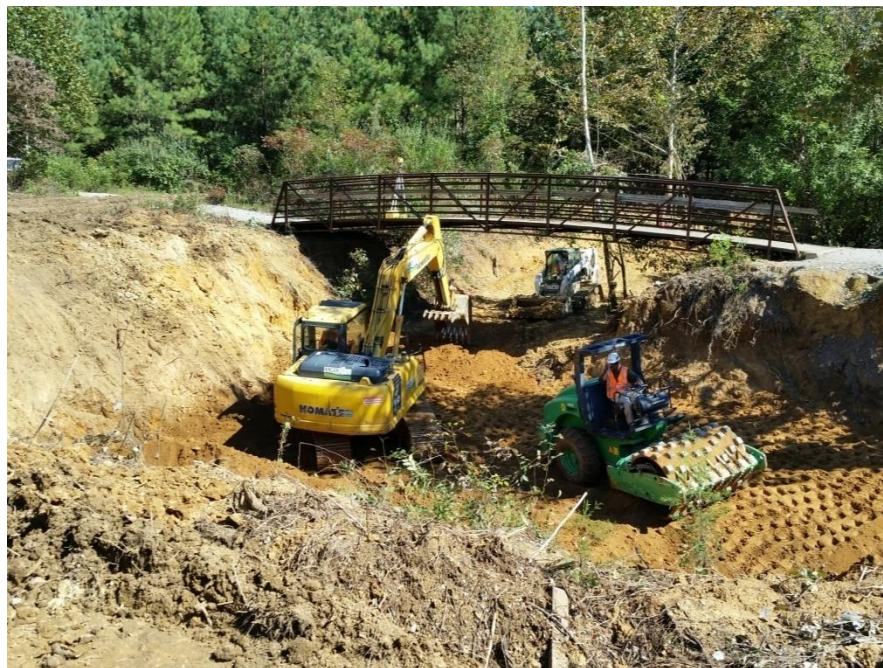
***Filling ravine with compacted soil fill (Looking upstream/RT at ~Sta.106+00). Pool subgrade under bridge was raised 8'+ to protect bridge abutments and reduce risk to fisherman and pedestrians of deep pools with steep banks.***

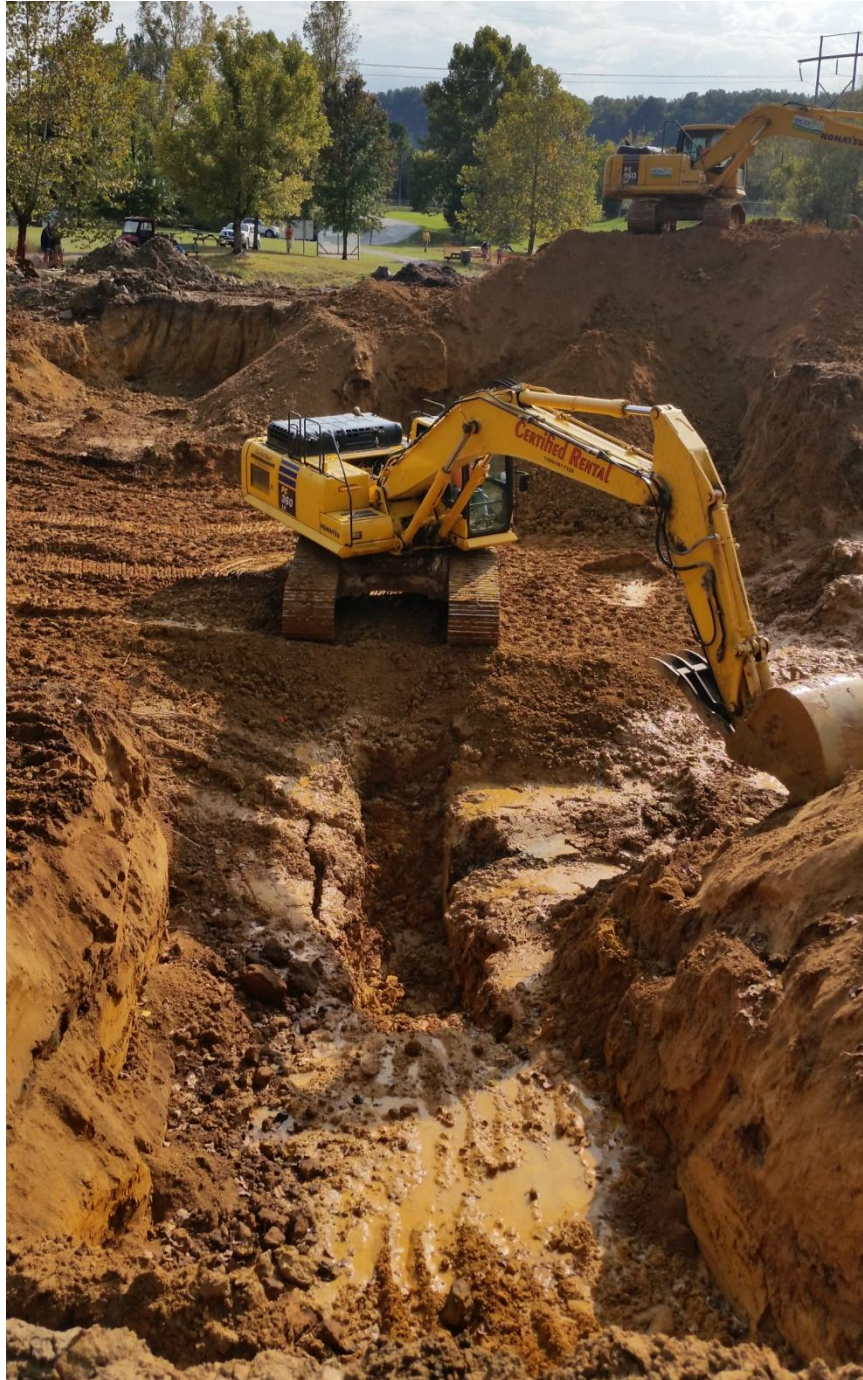
***Excavating trench to install compacted clay core (looking upstream across ravine toward Hatchery at ~LT Sta.107+00).***

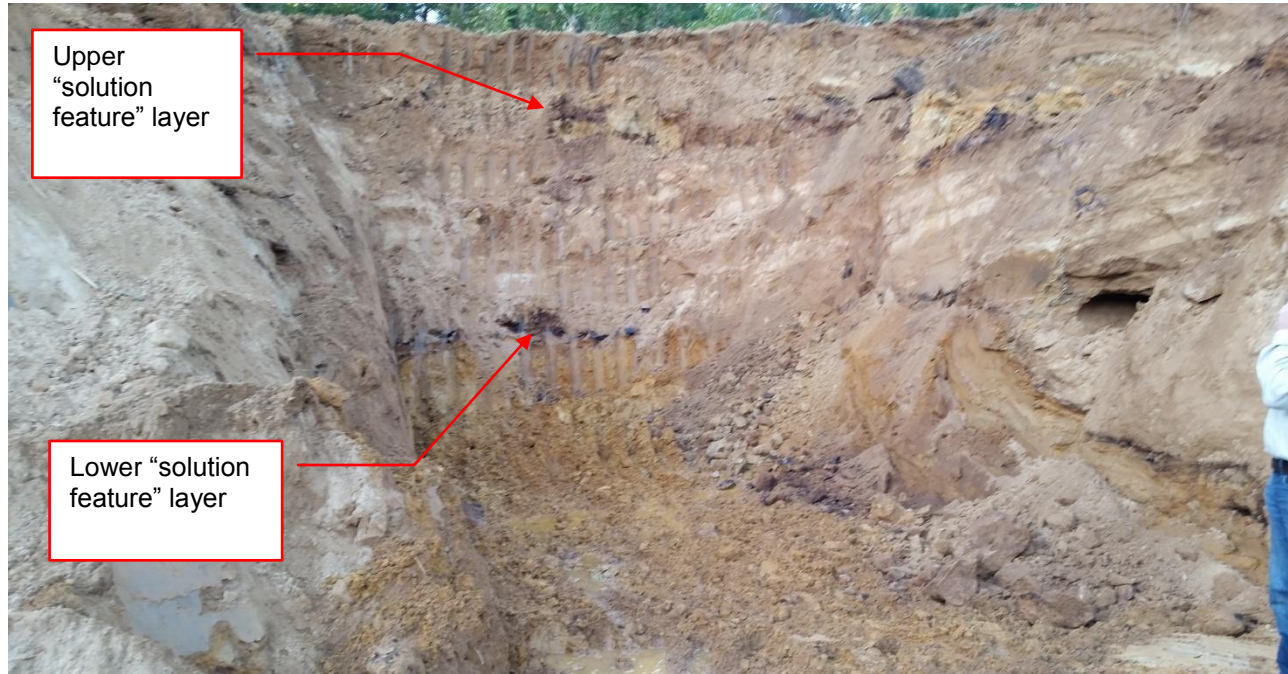
***Core trench showing "solution feature" layers in existing ravine soil bank similar to layer along temporary diversion (looking downstream from ravine at ~LT Sta.106+60).***

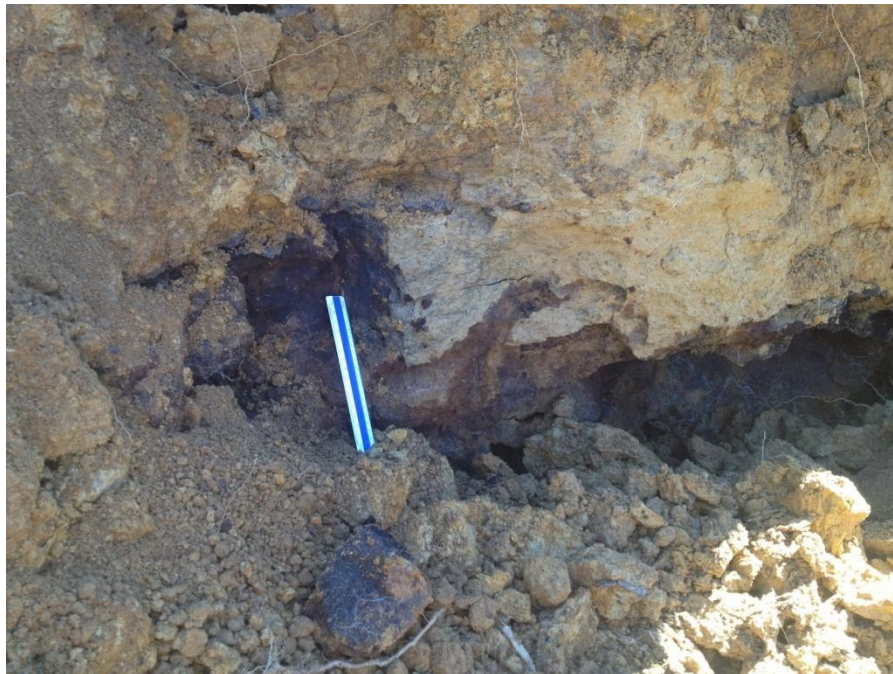
***"Solution feature" layer (brownish/blackish mineral layer) in existing ravine soil bank (6" scale shown for reference).***

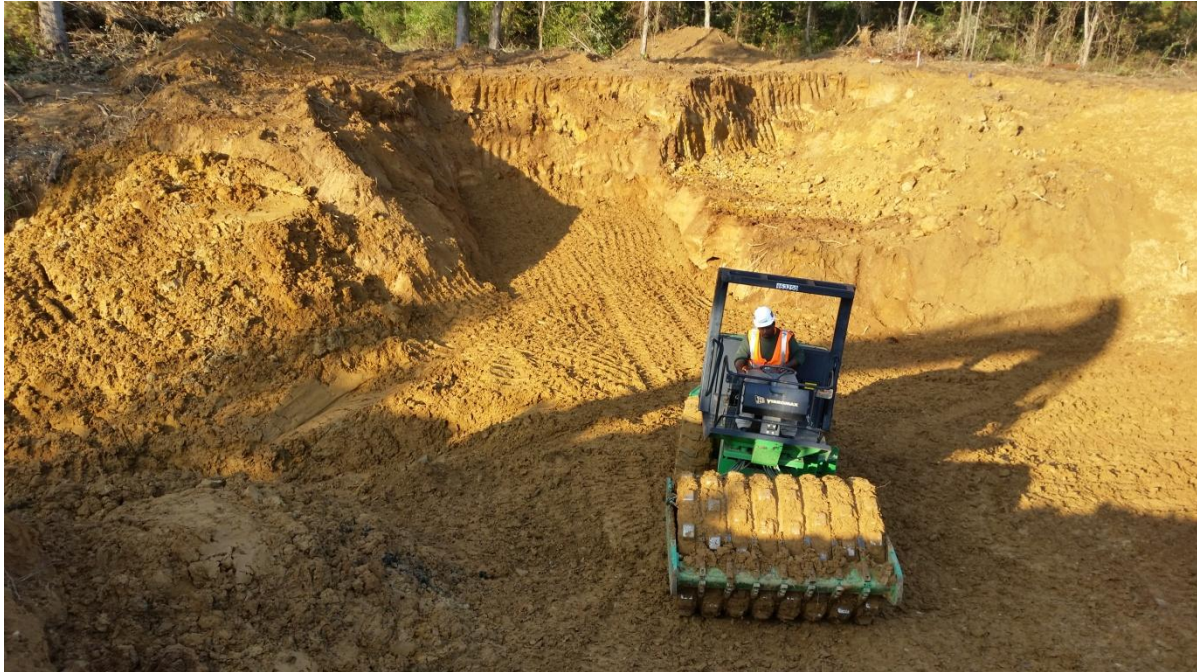
***Compacting clay core built up to ~ Elev. 577' (looking downstream across ravine at ~LT Sta.105+80).***
